## Strata LMS 879 Riverpointe Depreciation Report

The Owners, Strata LMS 879  
Riverpointe  
15110 - 15160 108 Avenue  
Surrey, BC, V3R 0T6

September 19, 2014

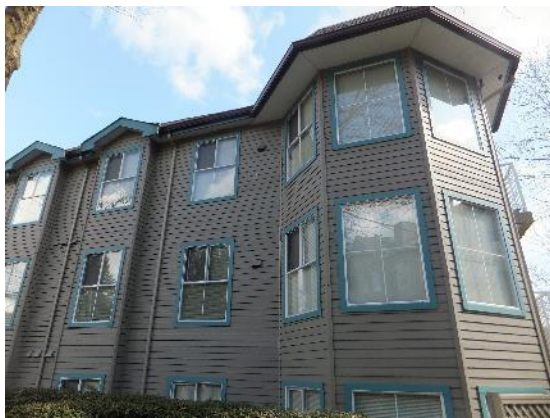
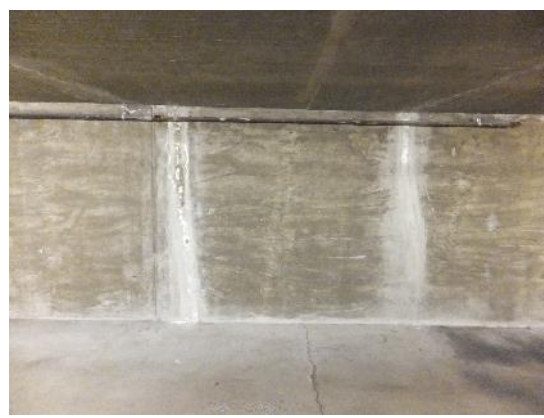
**S1 – Foundation & Structure**

<b>Year Installed</b>	1994	<b>Description:</b> The buildings have conventionally reinforced cast-in-place concrete foundation walls and columns that support the superstructures. The foundation walls likely sit on cast-in-place concrete strip footings and columns supported by reinforced pad footings. There are concrete slabs-on-grade within the parkades located below the buildings that are sloped to catch basins for drainage. There are also crushed stones along the perimeters of the exterior foundation walls to assist in directing water to the perforated drainage tiles at the base of the footings.  The above-grade framing of the buildings consist of wood-framed superstructures, including floor joists, stud wall framing, engineered wood roof trusses and columns and beams that sit on top of the suspended reinforced concrete roof slabs of the parkade.
<b>Expected Life Span</b>	80+	
<b>Observed Condition</b>	19

**Repair History:** We understand that the foundations and structures are part of the original construction. We are not aware of any replacements or significant repairs to this component. Isolated occurrences of leaks and cracks have been repaired from the operating fund.

**Visual Review:** The wood-framed structure and foundation of the building were typically concealed by exterior cladding and finishes. As indicated on the architectural drawings, the exterior side of the foundation were to be protected with a damp-proofing or waterproofing membrane but this could not be confirmed through a visual review at all locations. The interior sides of the foundation walls, viewed from within the parkade, had white painted parking lines painted on the surface of the slab-on-grade and stall numbers painted on the walls. From the interior of the parkade we noted some typical cracking and spalling along the foundation walls. We also noted some efflorescence which could indicate past water ingress; however, we noted no active leaks during our inspection.

**Recommendations:** The foundation and structure can deteriorate due to several factors such as hydrostatic pressure, seismic activity, and water infiltration through the cracks in foundation walls and exterior wall cladding, as well as typical building settlement. Foundation walls located below grade are susceptible to leakage if cracks form along the walls allowing moisture to penetrate into the parkade area.

Structural components typically last the life of the buildings, so full replacements have not been considered. However, there is potential for failure for some of the waterproofing. In the plan we have included an allowance for isolated concrete repairs to the below-grade perimeter foundation walls every 15 years to address any cracked or spalled areas and to mitigate water penetration, starting in 2018. Typically these repairs would include the injection of waterproofing materials into cracks along the concrete foundation walls. Similar repairs to the parkade floor and ceiling slabs have been included (refer to S2—Parkade).

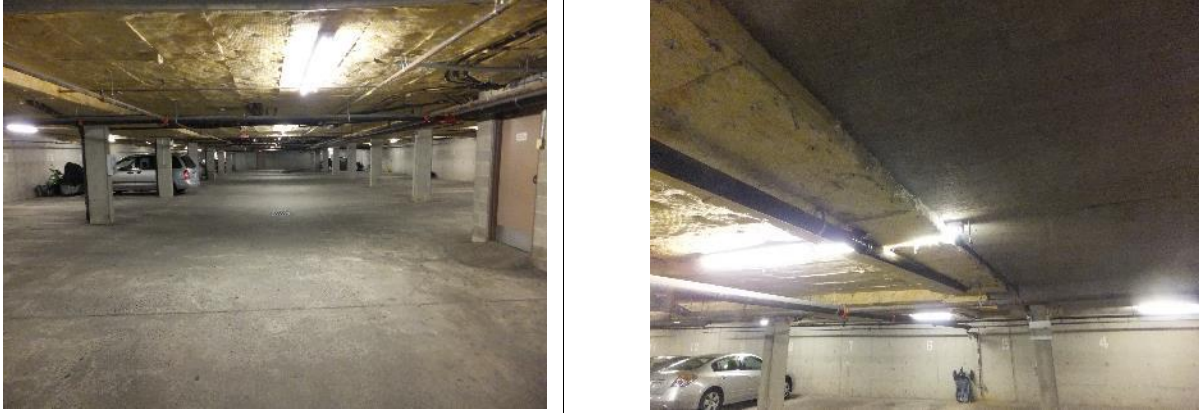
S2 – Parkade		
<b>Year Installed</b>	1994	<b>Description:</b> There is a two-storey parkade below the MacKenzie building; the suspended slab is typically covered with a traffic topping. There are also individual single-storey parkades located below the footprints of the other five buildings. The parkades have reinforced suspended concrete roof slabs that support the above-grade wood superstructure of the buildings. Portions of the roof slab/deck, extend beyond the exterior wall framing of the buildings creating a buried roof deck that is protected with a waterproofing membrane below hard and soft landscaping materials. This includes all of the individual patio pads of the 1st floor. Lighting of the parkade areas is provided by fluorescent lights.
<b>Expected Life Span</b>	various	
<b>Observed Condition</b>	19	
<b>Repair or Replace</b>	various

<p><b>Repair History:</b> Through Strata minutes, we learned that some repairs in the amount of \$12,675 were done in 2013 by Nova Concrete to prevent water ingress into the parkade. We are not aware of any other major repairs or replacements.</p>

<p><b>Visual Review:</b> It is assumed that concealed components, such as steel reinforcements and joints with water-stops, were designed in accordance with the building code and that they were installed as specified. The majority of the ceiling was covered by insulation and visibility was limited.</p> <p>Where checked, we noted some localized areas of efflorescence at the ceiling. There were also some typical cracking at the ceiling and floor slabs. The catch basins were noted to be unclogged and there were no signs of pooling water.</p>		
<p><b>Recommendations:</b> The reinforced concrete structure of the parkade is susceptible to deterioration that can rapidly accelerate due to exposure to moisture and de-icing salts. Moisture and salts may enter through cracks and come in contact with the reinforcing steel within the slabs causing it to oxidize and detach from the concrete surrounding it. Periodic concrete repairs and replacement of the membrane on the surface of the roof deck are required to keep the structure protected. Periodic injection of waterproofing material into cracks at the underside of the exposed parkade roof deck can also be completed to mitigate any water infiltration. These injections may assist in deferring replacement of the waterproofing membrane, but are not a permanent solution.</p> <p>To maintain longevity, some repairs should be performed to keep the structure protected. Typically these repairs would include routing and sealing of cracks, installation of new elastomeric waterproofing membrane on the suspended floor slab, and re-waterproofing the parkade roof decks. This includes the removal and replacement of the overburden/landscaping materials.</p> <p>We have included a provision for some isolated concrete repairs projects to address some cracked or spalled areas of the parkade with the foundation repairs (refer to S1—Foundation &amp; Structure). Assuming the completion of the planned repairs, as needed, and that there are no chronic leaking issues, we have reserved for a two-year phased replacement of the buried roof deck waterproofing membrane in 2028 and 2029. Future replacements are planned for every 30 years thereafter. Consistent with typical lifespans, replacement of the traffic topping is planned for 2019 and every 25 years thereafter.</p>

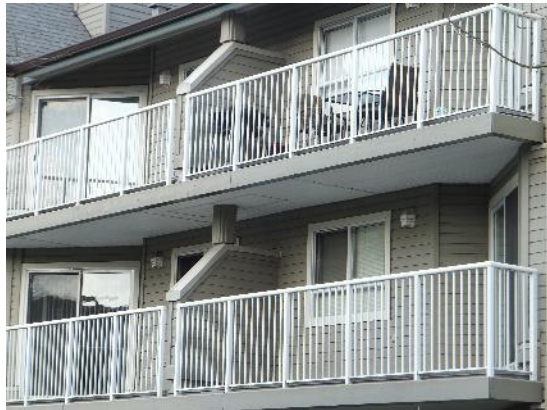
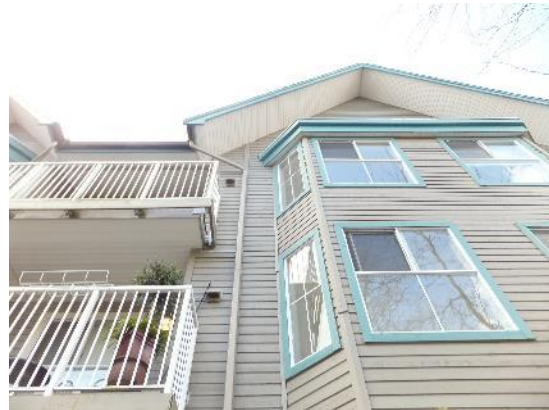
S4 – Balconies, Guards, Metal		
<b>Year Installed</b>	2009	<b>Description:</b> The balcony guard assemblies consist of aluminum picket style guards, which are side-mounted to the outer perimeter edge of the balconies.
<b>Expected Life Span</b>	40-50	
<b>Observed Condition</b>	4	
<b>Repair or Replace</b>	n/a

**Repair History:** We understand that the balcony guards, as mentioned above, were replaced as part of the large rehabilitation project in 2009. The total cost of the entire project was \$5,185,250 and was funded through special levies.

**Visual Review:** Our observations from grade led us to assume that all guards are similar. Where checked, the appearance of the balcony guards was consistent throughout the buildings and they appeared to be secured attached with no abnormal damages noted.

**Recommendations:** Metal guard assemblies have a typical life expectancy of 40-50 years. We recommend that along with the annual inspection of the balcony assemblies the Strata take note and monitor the condition and the firm attachment of the guards as well.

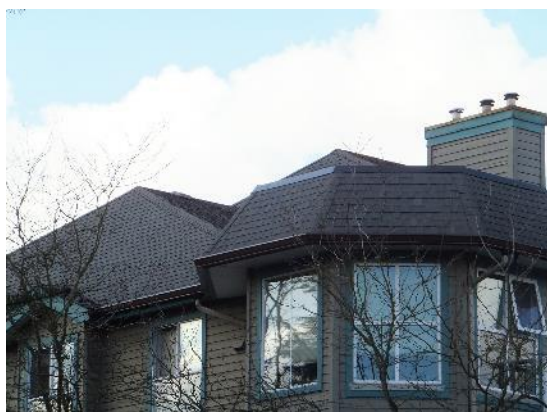
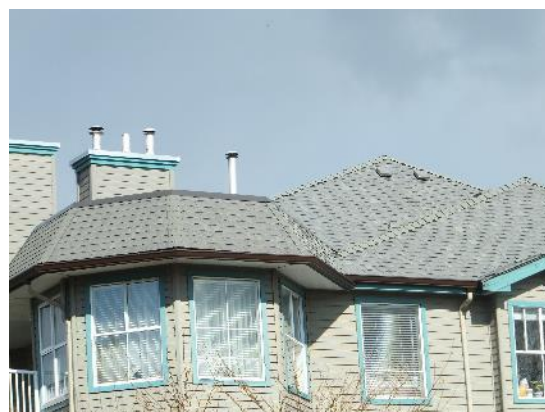
EE2 – Sloped Roofing		
<b>Year Installed</b>	2013	<b>Description:</b> Asphalt shingles are installed throughout the sloped roofs of the building. There is a main roof that covers the top of each of the buildings.
<b>Expected Life Span</b>	20-25	
<b>Observed Condition</b>	1	
<b>Repair or Replace</b>	2037

**Repair History:** We understand that \$1,000,000 was approved in 2013 for the complete roof replacements of the buildings. It was also approved to fund the project with \$200,000 from the contingency reserve fund and the remaining \$800,000 through a one-time special levy. As of the date of our site inspection, four buildings (Capilano, Thompson, Fraser, and Seymour) were completed. We were advised by the Caretaker that the two remaining buildings (MacKenzie, Harrison) is scheduled for completion this year.

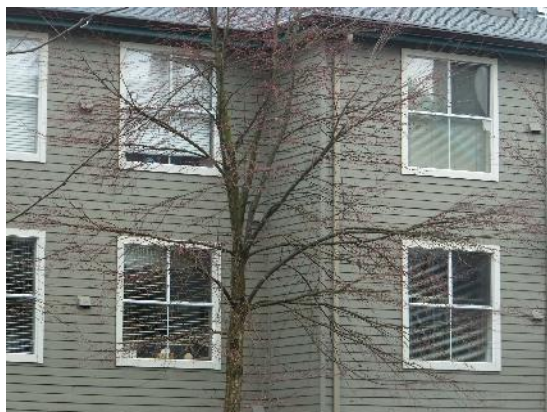
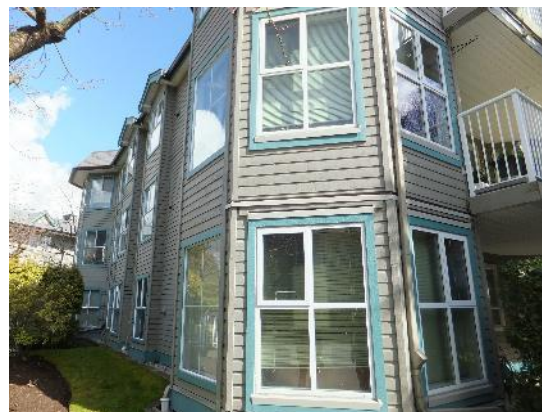
EE3 – Exterior Cladding		
<b>Year Installed</b>	1994, 2009	<b>Description:</b> The building is primarily clad with horizontal wood siding. The majority of the cladding utilise a face-sealed system. Some sections of the cladding incorporate rainscreen technology consisting of an air cavity behind the cladding surface for ventilation and drainage.
<b>Expected Life Span</b>	30-40	
<b>Observed Condition</b>	19, 4	
<b>Repair or Replace</b>	2026

**Repair History:** We understand that some targeted repairs to the cladding, particularly at the "turret" sections, were done as part of a large rehabilitation project in 2009. As mentioned above, the total cost of the project was \$5,185,250 and was funded through special levies.

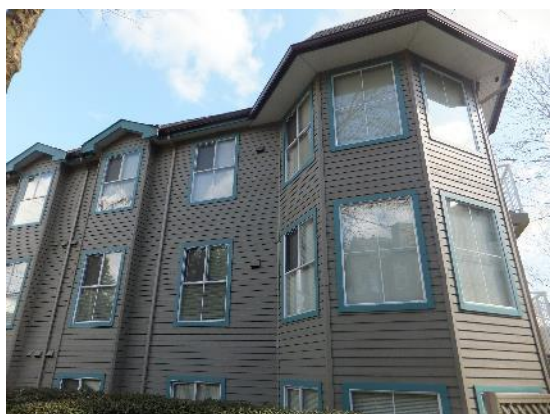
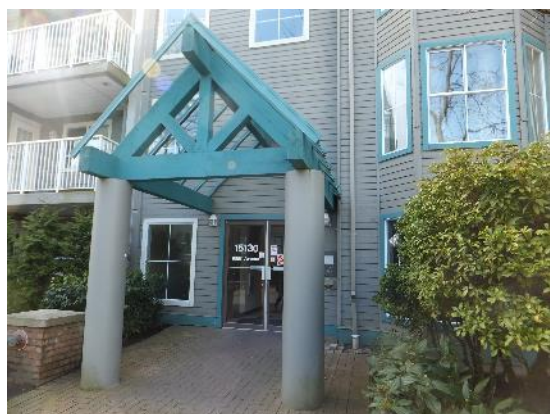
**EE4 – Windows & Sliding Doors**

<b>Year Installed</b>	1994	<b>Description:</b> The windows and sliding glass doors consist of double-glazed aluminum-framed units. There is an assortment of fixed and operable window assemblies. There are metal head flashings installed above the windows.  There are also glazed panels at the top of the entrance canopies.
<b>Expected Life Span</b>	25-35	
<b>Observed Condition</b>	19	
<b>Repair or Replace</b>	2026

**Repair History:** We understand the majority of the windows and sliding doors are original to the building construction. We are not aware of any major repairs or replacements.

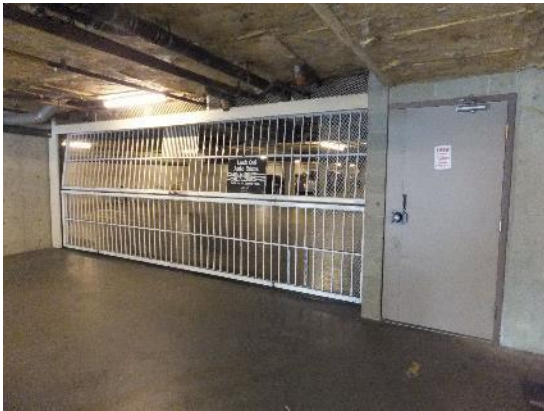
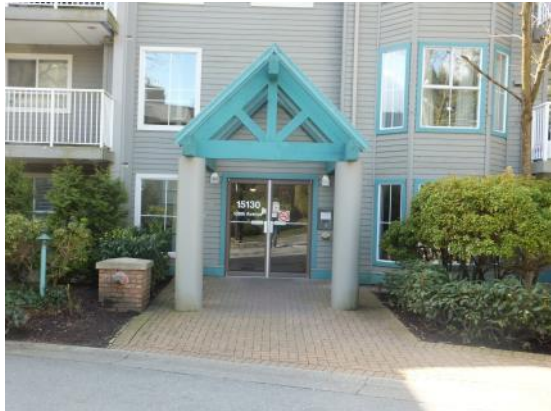
EE5 – Exterior Doors		
<b>Year Installed</b>	1994	<b>Description:</b> Common exterior doors include the parkade gates, the service room doors, main lobby entrance doors, exit doors, and balcony swing doors. There is a storefront door assembly that provide access into the main lobbies of each building. There is a prefinished metal overhead door with fixed pickets that provides access to each parkade. The parkade gates are controlled remotely. Service doors and exit doors consist of metal swing doors. There are also some balcony swing doors with glass inserts. The doors are equipped with self-closers and other standard locks and hardware.
<b>Expected Life Span</b>	various	
<b>Observed Condition</b>	19	
<b>Repair or Replace</b>	2019

<p><b>Repair History:</b> We understand the exterior doors are original to the building construction. We are not aware of any major repairs or replacements.</p>

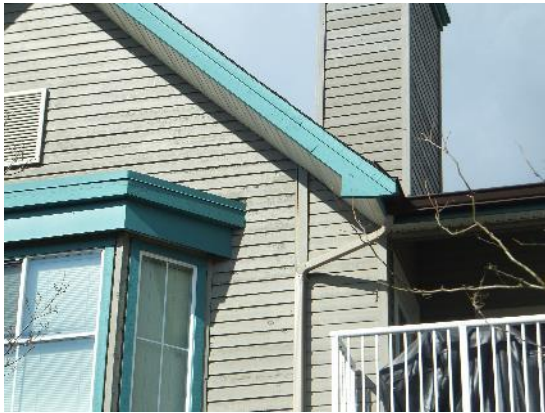
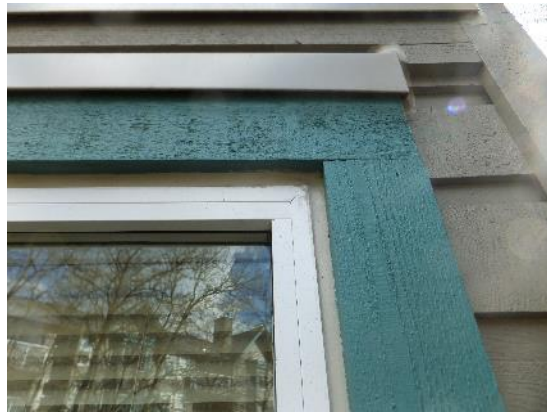
EE6 – Exterior Painting & Caulking		
<b>Year Installed</b>	2009	<b>Description:</b> Exterior components that are typically painted include the exterior cladding, the wooden fascia that surround the outer edges of the balconies and the bottom of the sloped roof perimeters, and the wooden trim boards that surround window and sliding door openings.
<b>Expected Life Span</b>	8-10	
<b>Observed Condition</b>	4	
<b>Repair or Replace</b>	2017	Sealants are applied at window and door perimeters, as well as at transition joints between the siding and other building components.

**Repair History:** We understand that painting and caulking of the buildings, as mentioned above, were part of the large rehabilitation project in 2009. The total cost of the entire project was \$5,185,250 and was funded through special levies.

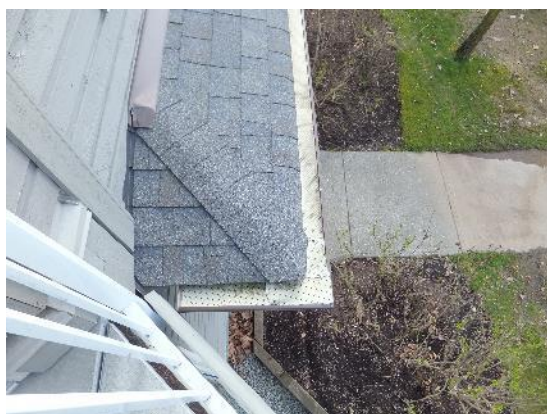
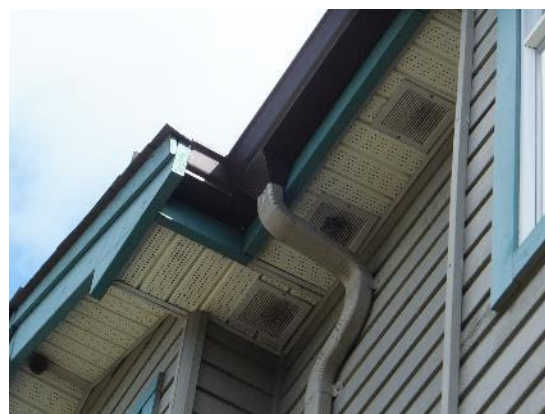
<b>Year Installed</b>	2009	<b>Description:</b> There are perforated aluminum soffits installed at the underside of roof overhangs and balconies throughout the buildings. There are aluminum gutters and downspouts installed for drainage of the roof areas.
<b>Expected Life Span</b>	30-40	
<b>Observed Condition</b>	4	
<b>Repair or Replace</b>	n/a

**Repair History:** We understand that the gutter system, which presumably includes downspouts, was replaced in 2009 as part of the large rehabilitation project mentioned earlier. As indicated by the Certificate of Completion, the total cost of the project was \$5,185,250 and was funded through special levies. We did not, however, see an itemized work contract and are not aware of the costs associated specifically with the gutter system.

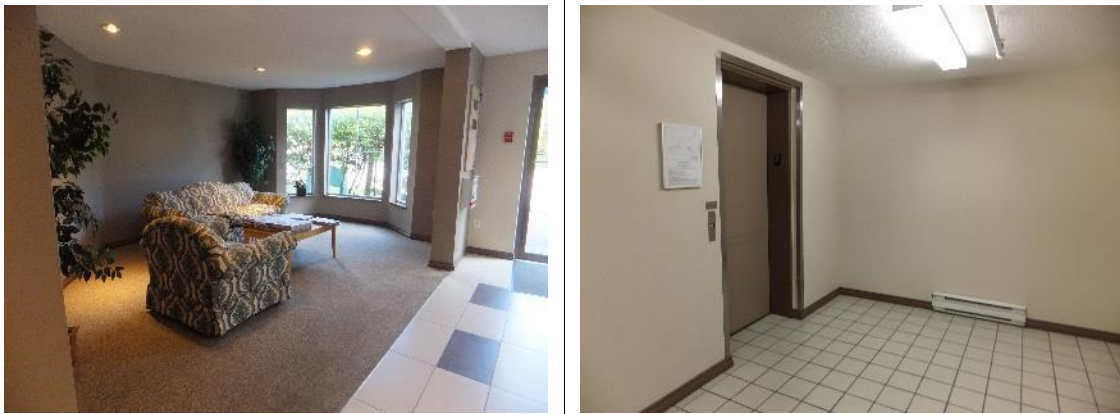
I1 – Lobbies & Vestibules		
<b>Year Installed</b>	2010	<b>Description:</b> The main entrance lobby and vestibule of each building is covered with tiles, painted walls and ceilings. Some of the lobbies also have sections covered with carpet. Components within the lobbies include but are not limited to several upholstered sofas and wooden coffee tables. Lighting of the lobbies and vestibules are provided by pot lights and fluorescent fixtures, respectively.
<b>Expected Life Span</b>	10-15	
<b>Observed Condition</b>	3	
<b>Repair or Replace</b>	2024

<p><b>Repair History:</b> Through Strata minutes, we learned that an interior refurbishment project took place in 2010. The project included the painting and re-carpeting/re-tiling of all common interior areas, including the amenity areas. The total cost of the project was \$369,560.82 and was funded through a combination of special levies and contingency reserve fund.</p>

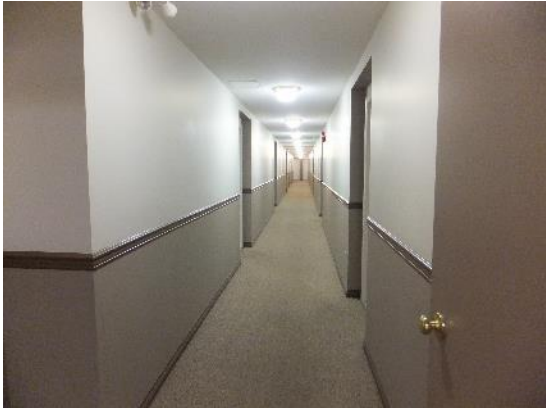
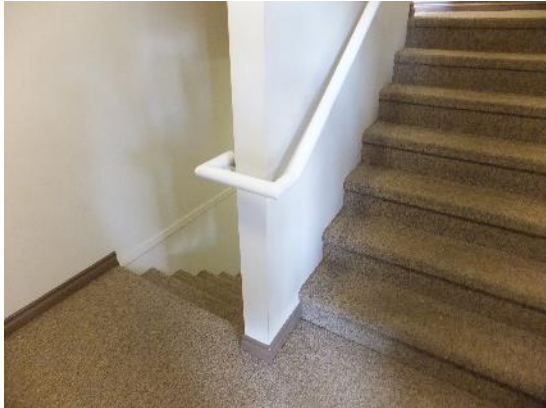
I2 – Corridors & Stairwells		
<b>Year Installed</b>	2010	<b>Description:</b> The corridors and stairwells are finished with carpeted flooring, and painted walls and ceilings. Lighting of these areas is provided by ceiling-mounted fixtures.
<b>Expected Life Span</b>	10-15	
<b>Observed Condition</b>	3	
<b>Repair or Replace</b>	2024	
<div style="display: flex; justify-content: space-around;">

</div>		
<p><b>Repair History:</b> We understand that the replacement of the carpets and the painting of walls and ceiling at the corridors and stairwells were part of a large interior refurbishment project in 2010, as mentioned above. The total cost of the project was \$369,560.82 and was funded through a combination of special levies and contingency reserve fund.</p>		
<p><b>Visual Review:</b> We noted no major damage to the interior finishes within the corridors or stairwells. Any minor scuffs noted were attributed to owner/tenant moving of furniture or similar items but were not deemed to be serious or concerning.</p> <p>Generally the carpeting was intact and all painted areas appeared to be clean and generally free of any noticeable damage. The light fixtures appeared to be consistent and in working order. Overall the corridor and stairwell interior finishes appeared in good condition and well maintained.</p>

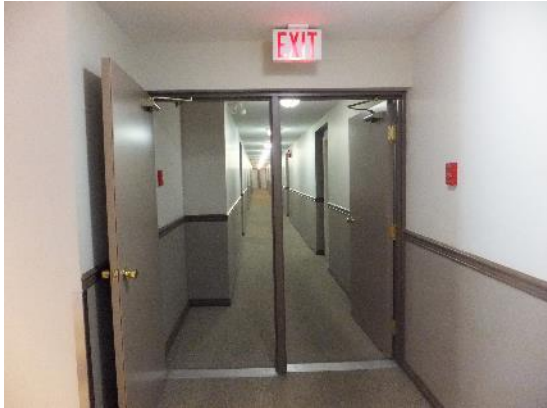
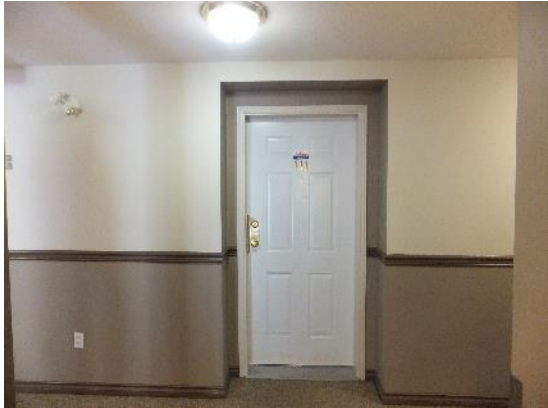
I3 – Interior Doors		
<b>Year Installed</b>	1994	<b>Description:</b> Interior doors include the individual suite entrance doors and the fire doors at each corridor. The suite doors consist of metal-skinned doors. The fire doors at the corridors consist of hollow metal doors.
<b>Expected Life Span</b>	10-30	
<b>Observed Condition</b>	19	
<b>Repair or Replace</b>	2022

<p><b>Repair History:</b> We understand the majority of the interior doors are original to the building construction. We are not aware of any major repairs or replacements.</p>		
<p><b>Visual Review:</b> Where checked, the suite doors were consistent and we noted no signs of damage or significant deterioration. They were noted to operate properly and close firmly into their frames. We did not note any issues with the self-closing mechanisms at the firewall locations.</p>		
<p><b>Recommendations:</b> Interior doors will generally remain functional for many years. However, there is potential for failure of the closers, locks, hinges, handle-sets, etc.</p> <p>The interior doors are not expected to require a full replacement at the same time. Localized repairs are assumed to be funded through the operating budget. We reserved an allowance for major repairs or replacements of some interior door assemblies. This budget is reserved for 2022 and every 10 years thereafter. As the corridor fire doors are intended to resist the rapid spread of fire in the case on such an incident, their condition is critical. We recommend their regular inspection to ensure their proper working condition.</p>

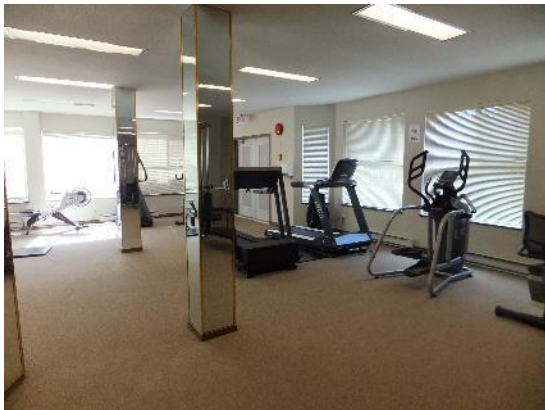
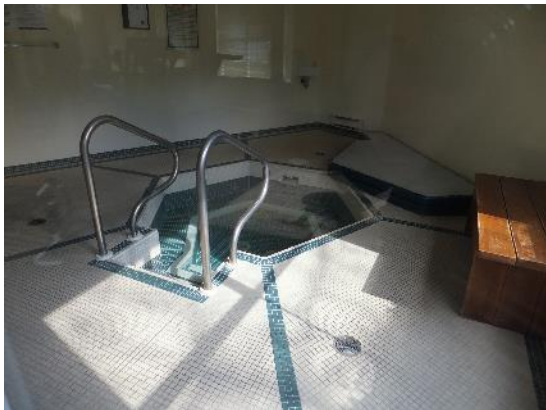
<b>Expected Life Span</b>	10-15	
<b>Observed Condition</b>	3	
<b>Repair or Replace</b>	n/a

<p><b>Repair History:</b> We understand the exercise room was re-carpeted as part of a larger interior refurbishment project in 2010, as mentioned above. The total cost of the project was \$369,560.82 and was funded through a combination of special levies and contingency reserve fund spending. We were advised by the Caretaker that the whirlpool heater was recently replaced and the jet pump was recently rebuilt. We are not aware of the costs involved but assumed it was taken care of through the buildings' maintenance budget.</p>		
<p><b>Visual Review:</b> Review was based on visual inspection without any specific testing of equipment.</p> <p>Where checked, the carpet and tiles were clean and without any noticeable damage. The walls were noted to be consistently painted. The exercise equipment appeared to be in good condition and well maintained. Lighting of the area was noted to be in working condition.</p>

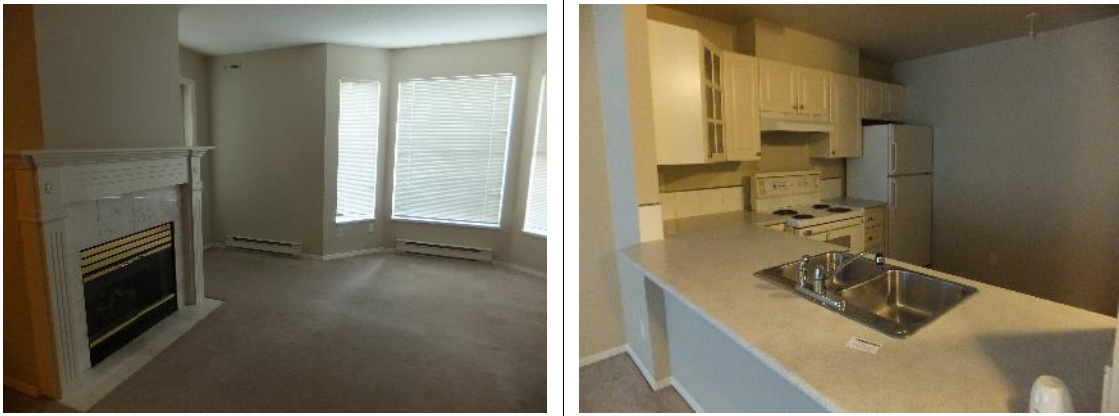
I6 – Amenities - Caretaker Suite		
<b>Year Installed</b>	1994	<b>Description:</b> There is a Caretaker Suite at Unit #107 of the Capilano building. The suite is a currently vacant one-bedroom apartment unit with a three-piece bathroom, fully equipped kitchen, gas fireplace, and hot water tank. Interior finishes include carpet and ceramic flooring, and painted walls and ceiling. The kitchen consists of wooden cabinetry with a laminate countertop. Lighting is a common-use guest suite consisting of a one bedroom layout with a private full bathroom. The interior finishes include carpeted and linoleum flooring with painted drywall walls and ceilings. Lighting within the suite is provided by ceiling-mounted fixtures.
<b>Expected Life Span</b>	various	
<b>Observed Condition</b>	various	
<b>Repair or Replace</b>	n/a

<b>Repair History:</b> We understand that the guest suite is part of the original construction. We are not aware of any major repairs or replacements.

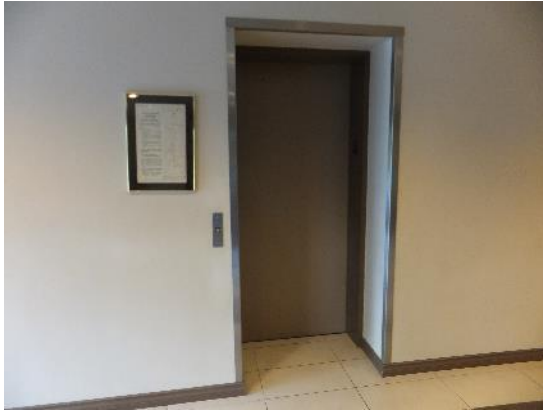
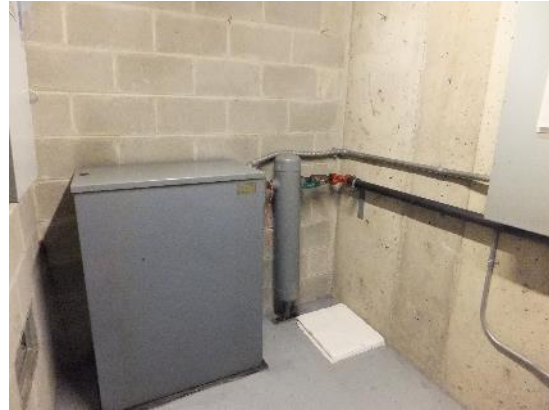
M1 – Elevators, Hydraulic		
<b>Year Installed</b>	1994	<b>Description:</b> There is a hydraulic elevator at each building serving all floors and the corresponding underground parkade. They are manufactured by Richmond Elevator Maintenance Ltd. and currently serviced by Schindler Elevator Corporation. The elevator machines, elevator controller and the main disconnect switches are each located within the respective elevator machine room at the parkade level. The switches are manufactured by Commander and are each rated at 100A.
<b>Expected Life Span</b>	25-30	
<b>Observed Condition</b>	19	
<b>Repair or Replace</b>	2019

**Repair History:** We understand the elevators are original to the building construction. We are not aware of any major repairs or replacements.

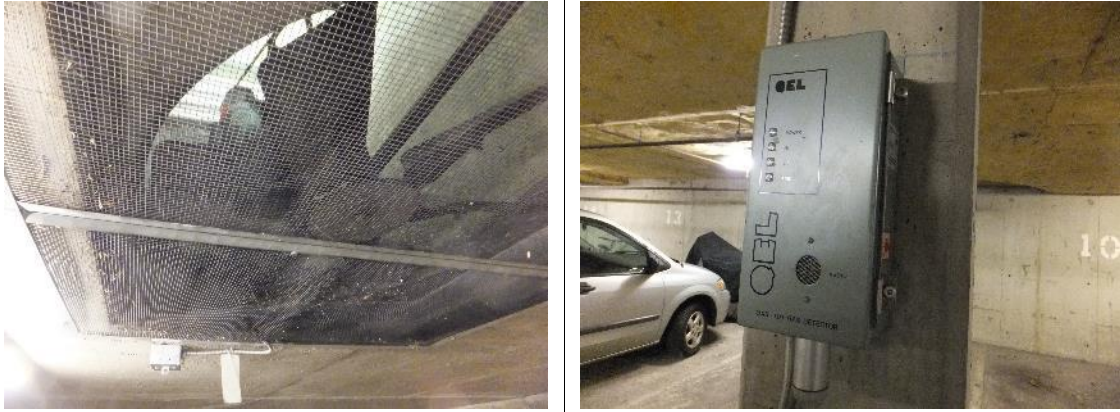
M3 – Parkade Ventilation & Exhaust		
<b>Year Installed</b>	1994	<b>Description:</b> There are wall-mounted exhaust fans and gas monitors located within the parkades. The gas monitors are manufactured by QEL Quatrosense Environmental Ltd. (Model QAS-101). There are also some smaller exhaust fans within individual service rooms.
<b>Expected Life Span</b>	15-20	
<b>Observed Condition</b>	19	
<b>Repair or Replace</b>	n/a

<p><b>Repair History:</b> We understand that the ventilation and exhaust systems are part of the original construction. We are not aware of any replacements or significant repairs to this component.</p>		
<p><b>Visual Review:</b> Where checked, we noted no abnormal wear or damage to the HVAC equipment. Based on our understanding, there have also been no complaints or unresolved issues regarding the units and they are assumed to be in good working condition.</p>		
<p><b>Recommendations:</b> The typical life expectancy of the ventilation system in the parkade is 15-20 years. Over time as new technologies emerge, replacement repair parts of the systems will become scarce and obsolete. Eventual replacement of the system is expected.</p> <p>As the parkade ventilation and exhaust equipment typically wear at different rates according to usage, they are not expected to require replacements at the same time. Their replacements costs are also expected to be below the Report threshold. As a result, and consistent with the Strata's past practice, we assume their replacements or repairs will continue to be funded through the operating budget on an as-needed basis.</p>

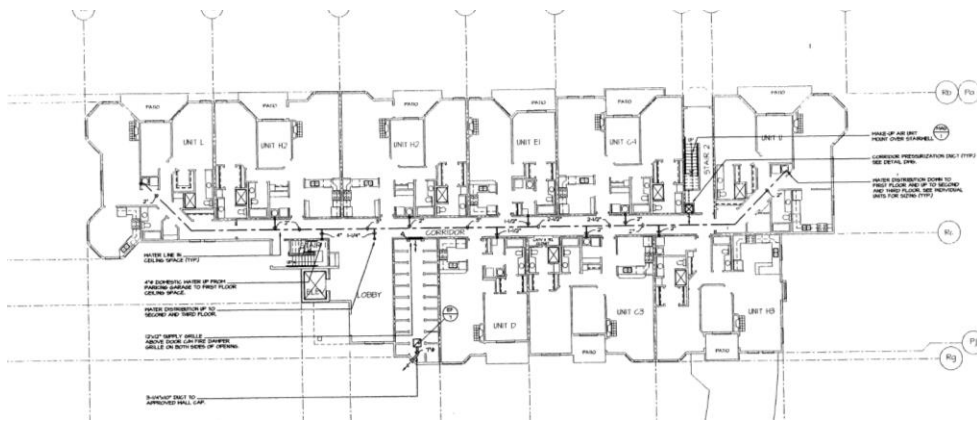
P1 – Domestic Water System		
<b>Year Installed</b>	1994	<b>Description:</b> Domestic water typically enters the buildings via buried piping fed from the main municipal line connected to a combined incoming domestic water and suppression line supply line through the parkade wall. The line splits into the domestic water line and suppression line. Domestic water is distributed to the building floors through horizontal runs concealed within the first floor ceiling space and further delivered to upper floors through risers. The water is heated by individual hot water heaters within the suites.
<b>Expected Life Span</b>	25-30	
<b>Observed Condition</b>	19	
<b>Repair or Replace</b>	2024

**Repair History:** We understand that the domestic water distribution piping is original to the building construction. We are not aware of any major repairs or replacements.

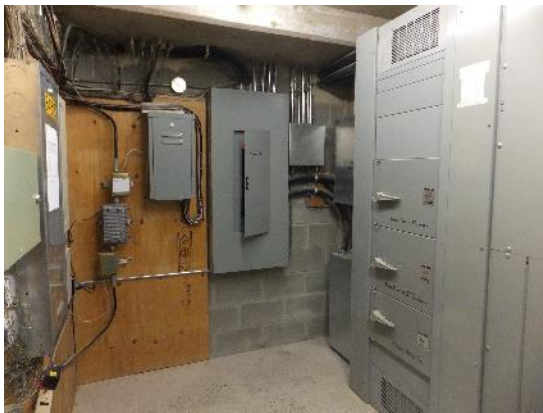
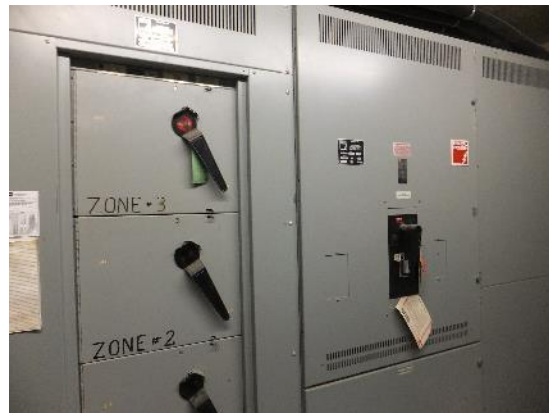
EL1 – Electrical System		
<b>Year Installed</b>	1994	<b>Description:</b> Electrical service is supplied to each building from buried municipal service supplied to various pad-mounted transformers that are presumably owned and maintained by BC Hydro and brought into the switchgear unit located in the main electrical rooms on the parkade level of each corresponding building. The units are manufactured by Commander and are rated at 1200A, 120/208V, 3-phase, 4-wire. The units house various meter centers that vary between 400A and 600A. The individual electrical meters are located within the electrical closets at the corridors.
<b>Expected Life Span</b>	50+	
<b>Observed Condition</b>	19	
<b>Repair or Replace</b>	2023

**Repair History:** We understand that the electrical systems are part of the original construction. We are not aware of any replacements or significant repairs to this component.

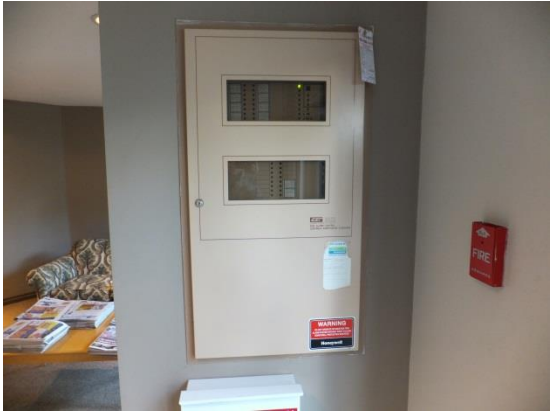
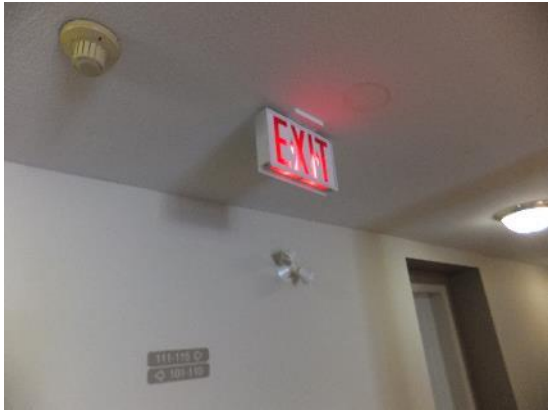
SS1 – Fire Alarm System & Emergency Power		
<b>Year Installed</b>	1994	<b>Description:</b> Each building is equipped with an Edwards Systems Technology (EST) 6632 fire alarm system. The annunciator panels are mounted on a wall within the main lobbies. There are fire bells, smoke detectors, battery-packed emergency lights and pull stations located throughout the common areas of the buildings.
<b>Expected Life Span</b>	25-30	
<b>Observed Condition</b>	19	
<b>Repair or Replace</b>	2021

<p><b>Repair History:</b> We understand that the fire alarm systems are part of the original construction. We are not aware of any major repairs or replacements to these components.</p>		
<p><b>Visual Review:</b> The functionality and operation of the system cannot be commented on as they could not be tested or reviewed during our site inspection. It was assumed that these systems are installed and maintained to industry standards and in accordance to current fire codes.</p> <p>We understand the fire alarm system is currently serviced by Legacy Fire &amp; Safety. The next service was indicated on the service tag to be due on or before June 27, 2014. The service is assumed to be completed since our inspection with no issues. We are unaware of any significant issues with the fire alarm system and emergency lighting. Assuming no unresolved issues, the system is believed to be in good working condition.</p>

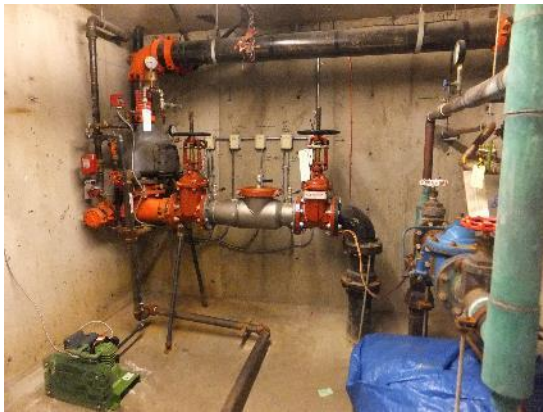
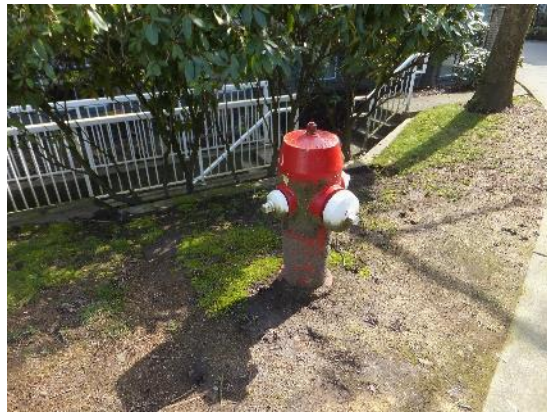
SS2 – Suppression System		
<b>Year Installed</b>	1994	<b>Description:</b> It is assumed that a combined incoming water line enters each building and branches into a suppression line that is protected with a backflow prevention valve. The buildings are each equipped with a dry suppression system that supplies the sprinklers of the parkade level and a wet suppression system that supplies the fire department connections located near the front entrances of the buildings. There are also fire extinguishers locked inside glass-faced cabinets within the buildings and fire hydrants located throughout the complex.
<b>Expected Life Span</b>	60	
<b>Observed Condition</b>	19	
<b>Repair or Replace</b>	2024

**Repair History:** We understand that the fire suppression lines are part of the original construction. We are not aware of any replacements or significant repairs to this component.

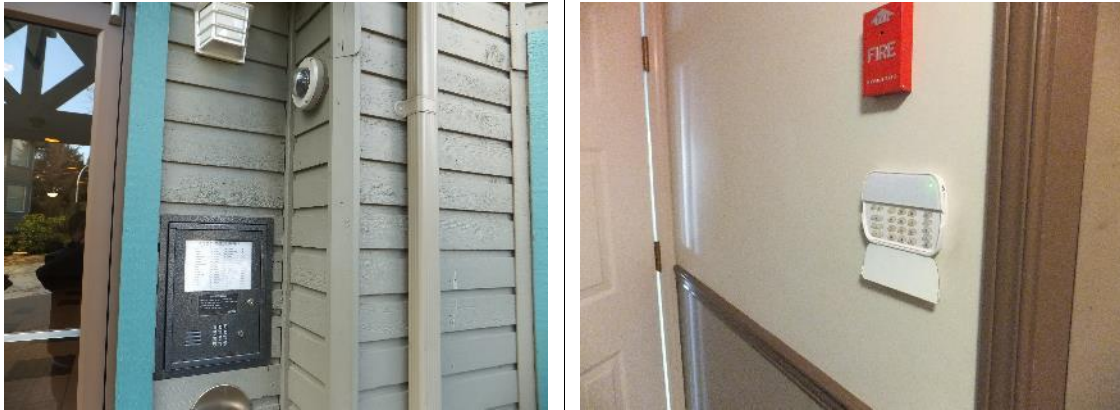
SS3 – Access Control & Security System		
<b>Year Installed</b>	1994	<b>Description:</b> There are wall-mounted enterphone panels located near the front entrances to the buildings. The enterphone systems are Enterphone 2000 systems manufactured by Viscount. The parkade gates are controlled remotely. There are two security cameras installed for each building. There is also an alarm system installed to protect the lounge.
<b>Expected Life Span</b>	25-30	
<b>Observed Condition</b>	19	
<b>Repair or Replace</b>	2021

<p><b>Repair History:</b> We understand the access control and security systems are original to the building construction. We are not aware of any major repairs or replacements.</p>		
<p><b>Visual Review:</b> We were advised by the Caretaker that the security cameras are currently inoperable. We are not aware of any reported issues with the enterphones. Our visual inspection did not uncover any signs of unusual or unexpected wear or deterioration. The alarm system for the lounge was noted to be in working condition.</p>

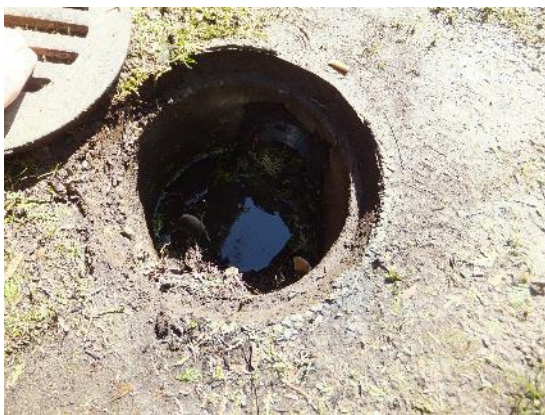
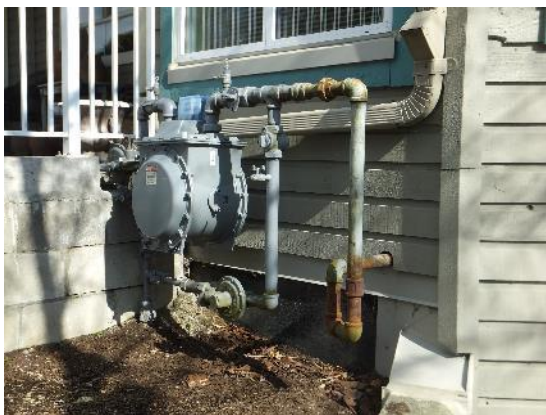
SRV – Buried Site Services & Drainage		
<b>Year Installed</b>	1994	<b>Description:</b> Site services include sanitary and storm piping, gas piping, and electrical wirings. They are supplied to the building via buried conduits and piping fed from main municipal lines below the adjacent roads. Site drainage is accomplished with natural sloping of the hard and soft landscaping components to various catch basins throughout the site. There is also an irrigation system for the complex and it is controlled through Hardie rain dial controllers that are wall-mounted within the Mechanical Rooms.
<b>Expected Life Span</b>	80	
<b>Observed Condition</b>	19	
<b>Repair or Replace</b>	n/a

<p><b>Repair History:</b> Through Strata minutes, we learned that a section of the water main was repaired in 2011. We did not see the work contract and are not aware of the scope and costs involved. We are not aware of any other major repairs or replacements to this component.</p>

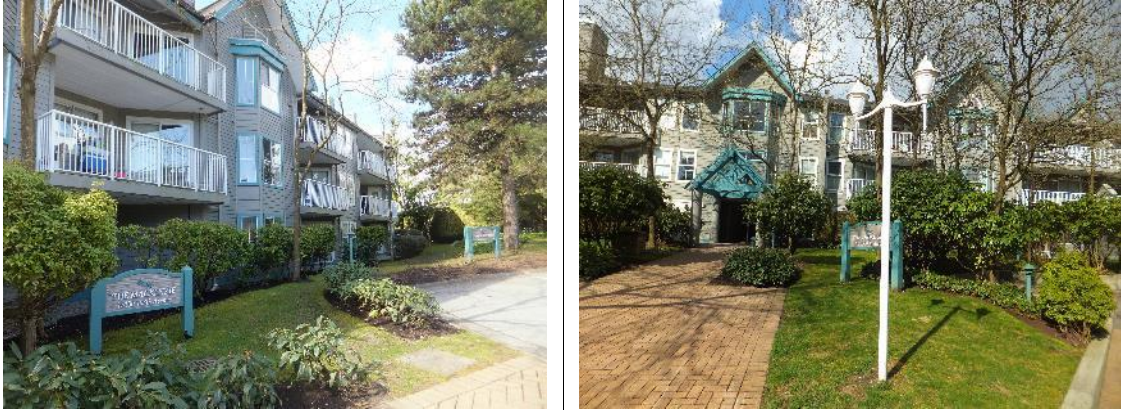
SITE2 – Landscaping & Miscellaneous		
<b>Year Installed</b>	1994	<b>Description:</b> Site landscaping consists of various hard and soft landscaping components. Soft landscaping includes the trees, shrubbery, flowerbeds and sodded areas that are incorporated throughout the site. Hard landscaping includes the masonry retaining walls, exterior lights, and the various signage of the property.
<b>Expected Life Span</b>	15-25	
<b>Observed Condition</b>	19	
<b>Repair or Replace</b>	2015

<p><b>Repair History:</b> We understand the majority of the landscaping is part of the original construction and is currently maintained by an independent landscaping contractor. We were advised by the Caretaker that numerous trees have been cut down due to roots imposing on the walkways. We understand that these have generally been funded through the building's annual maintenance budget.</p>		
<p><b>Visual Review:</b> The operation of the lights was not observed as our inspection took place during the daytime. Exposed wooden components are assumed to be pressure treated.</p> <p>The soft landscaping was generally well maintained. Some tree trunk stumps were noted throughout the complex. We were advised by Council that the trees were cut down in recent years due to their uplifting effect on adjacent walkways. We were also advised of a large dead tree behind the Seymour building and the Strata's plans to have it cut down in the coming year. Some of the wooden posts of the building signs were noted be deteriorating, specifically at their base.</p>

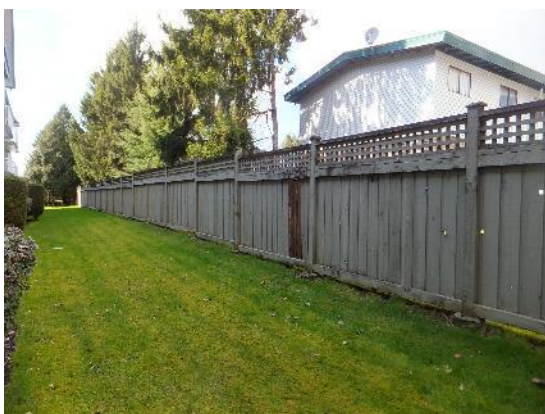
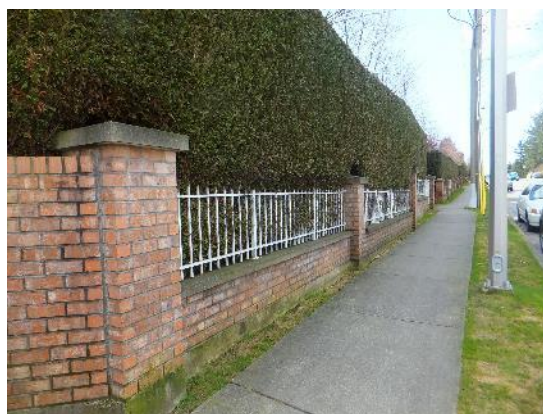
**Repair History:** We understand that the fencing and site guards are original to the building construction. We are not aware of any major repairs or replacements to these components.
